## Messerschmidt Safety Consultants

5 January 2018

*Re: Williams vs D&D Express*

The following report summarizes my investigation into and analysis of the 24 April 2016 motor vehicle crash involving a 1995 Buick Roadmaster and 2008 Freightliner Cascadia. The 1995 Buick Roadmaster was being operated at the time of the accident by Mr. Daryl Williams. Mr. Lamario Henderson, Larry Henderson, and Jametrius McCon were riding as Mr. Williams' passengers at the time of the crash. The 2008 Freightliner was being operated by Mr. Adolfo Perez at the time of the crash. Mr. Carlos Laguna was riding as Mr. Perez's passenger at the time of the crash.

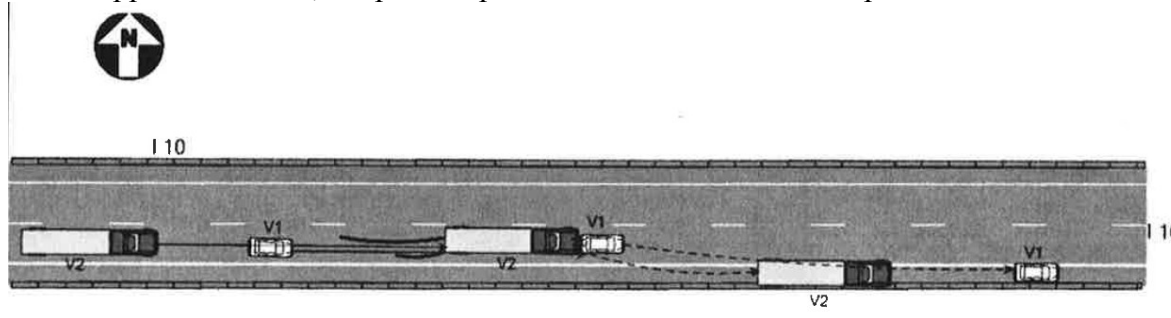
Figure 1: Diagram from Mississippi Uniform Crash Report

According to the crash report, the 1995 Buick was traveling in the right, outside lane. Mr. Williams indicated he ran out of gas and the vehicle came to an abrupt stop. The 2008 Freightliner was also traveling in the right, outside lane.

The collision occurred when Mr. Perez's 2008 Freightliner overtook Mr. Williams much slower-moving 1995 Buick and struck the rear offset slightly to the driver's side. After impact, both vehicles came to final rest in the eastbound emergency shoulder, facing east.

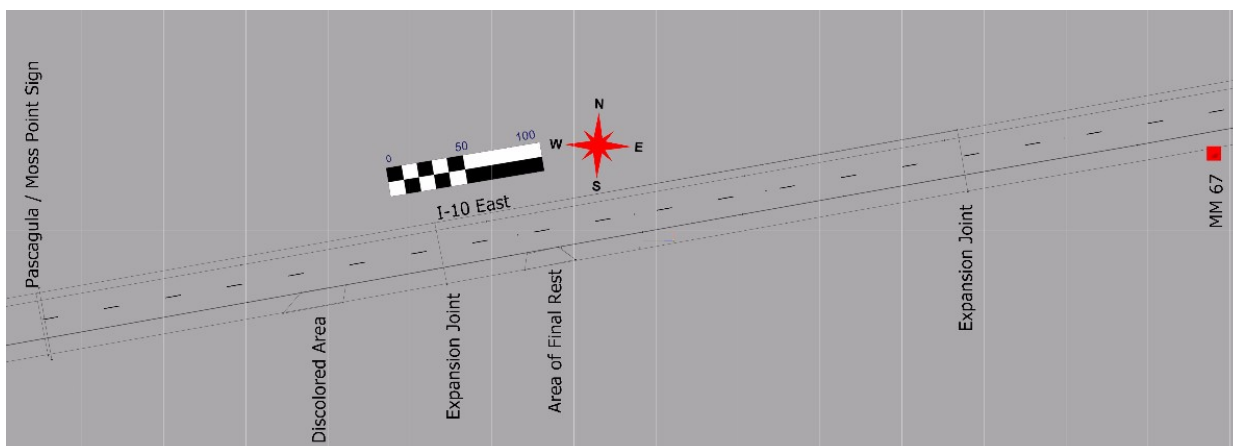
**Figure 2: Diagram showing potential 2008 Freightliner final rest.**

The location of final rest for the 2008 Freightliner was located using GPS coordinates and matching roadway markings found in trooper photographs with physical markings seen at the crash site.

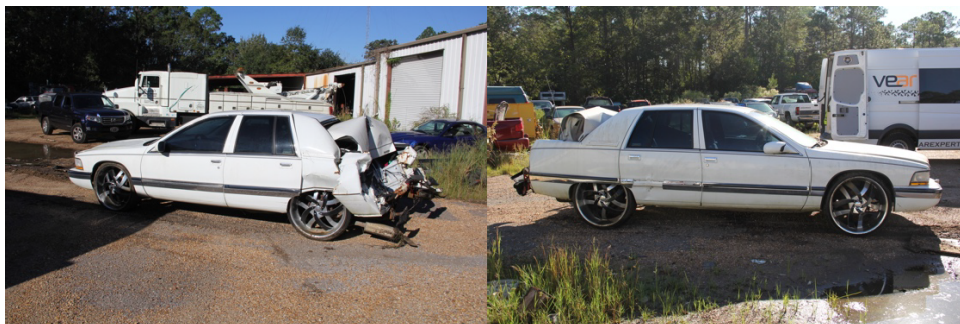
**Photograph: 1995 Buick Roadmaster**

On 17 October 2017, the 1995 Buick Roadmaster was inspected and photographed along with a lamp examination with Mr. Gary Johnson. It is a 4 door sedan with VIN 1G4BN52P2SR405417 and Mississippi license plate JHC689. The vehicle did not have any repairs completed between the time of the accident and time of inspection.

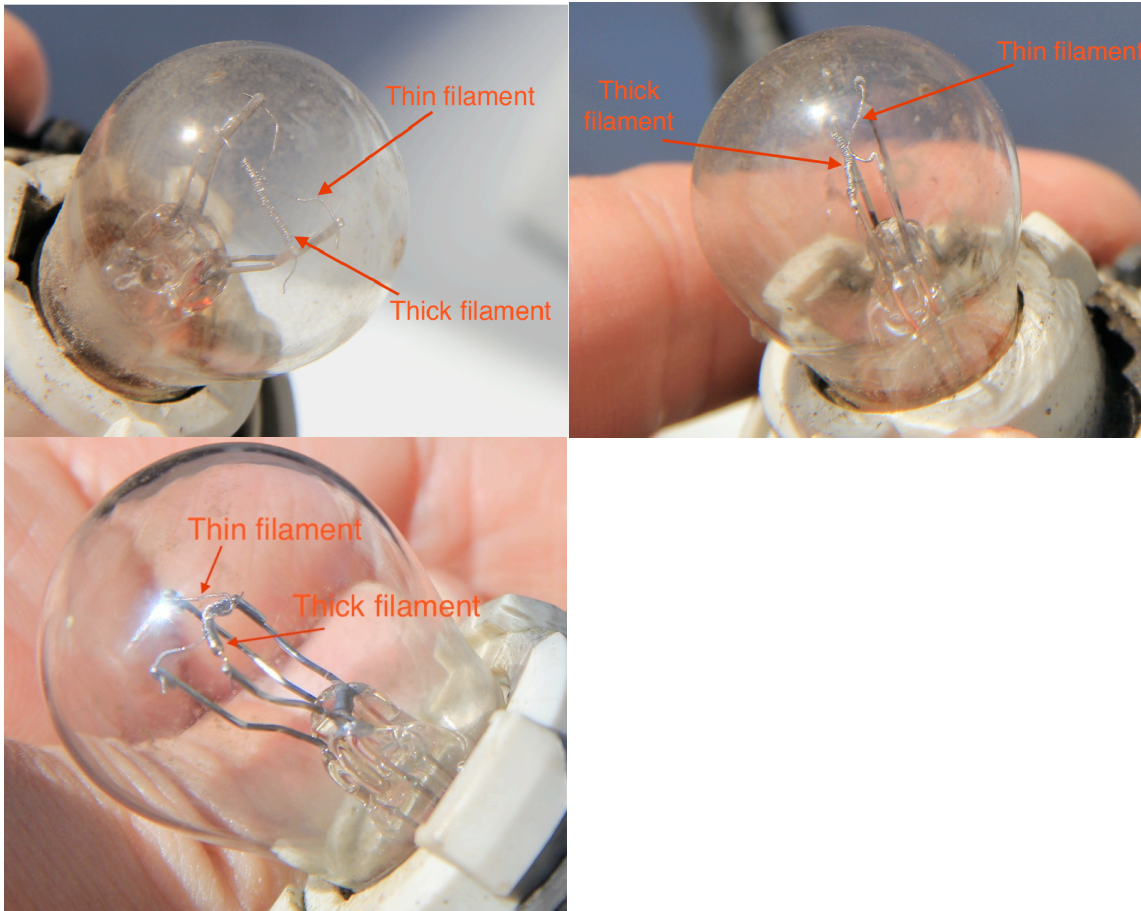
**Excerpts: Taillight bulb inspection**

The single filament bulbs that were inspected showed signs of "hot shock", which indicates the filament was incandescent or illuminated at the time of impact and the tail lights were on.

The dual filament bulbs that were inspected contain a thin wire and thick wire. The thin wire has a higher resistance to draw less current and give off less light, this wire is typically used for parking and tail lights. The thin wire filaments inspected did show signs of "hot shock" which again indicate they were incandescent at the time of impact and the tail lights were on. The thick

wire has a lower resistance to draw more current and give off more light, this wire is typically used for turn signals, brake lights, and hazard lights. The thick wire filaments inspected did not show the same clear indication of “hot shock”, instead they showed signs of bowing. Because both filaments are not equally deformed potentially indicates the thick wire filament was not incandescent at the time of impact and was hot because of it’s proximity to the incandescent filament. There is not enough evidence at this time to determine the status of the hazard lights at the time of impact. (Baker) Therefore, one cannot state to a reasonable degree of scientific probability that the hazard lights were on or not on at the time of the collision.

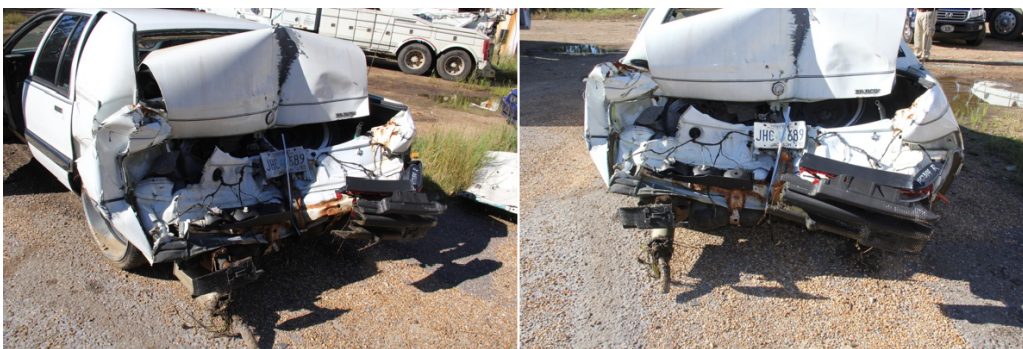
**Photograph: Crush damage**

The vehicle sustained damage to the rear, including damage to the rear bumper, trunk, and driver/passenger side quarter panels. Crush measurements were taken at the inspection to determine approximate closing speed. Based on these measurements, the Freightliner was offset to the driver’s side slightly.

The closing speed at impact between the two vehicles was estimated by using crush stiffness coefficients and crush measurements applicable to the 1995 Buick Roadmaster. The coefficients were applied to the measurements of the approximate width and depth of the damage compared to published vehicle dimensions.

Based on the analysis of the damage, the closing speed at impact was calculated to be approximately 45 miles per hour. (Robinson) (Tumbas & Smith) If the Freightliner was travelling between 52-58 miles per hour, that would put the Buick's speed at impact between 7-13 miles per hour. This is inconsistent with Mr. Williams response to interrogatories that they were travelling approximately 58 miles per hour moments before impact. This is also consistent with McCon's medical records where he stated they were traveling no more than 10 miles per hour.

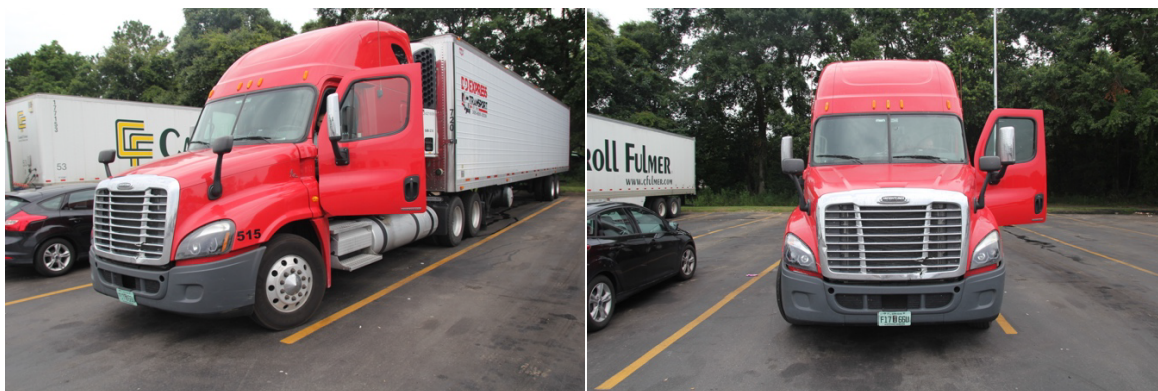
**Photograph: 2008 Freightliner at time of download**

On 15 June 2016, the 2008 Freightliner Cascadia was downloaded and photographed. The VIN was documented as 1FUJGLCK38LY72335 at this time with Florida tag F1766U. The tractor and trailer were both documented as D&D express with tractor number 515. At the time of this inspection, the majority of the damage to the tractor had been repaired, as the tractor had been put back in service. The front grille appeared to be the same as at the time of the accident. The ECM download was the only activity conducted, no other inspection of the tractor or trailer was done at this time.
